Moisture Inspection Report

Project Information

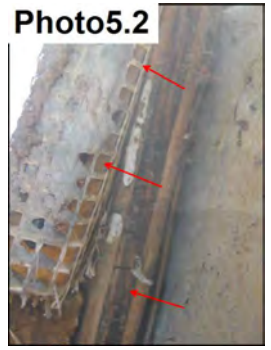
Photo5.2

Plywood, yellow insulation, white mesh.

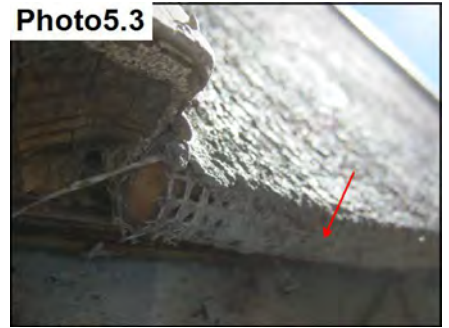
Photo5.3

Some areas back wrapped

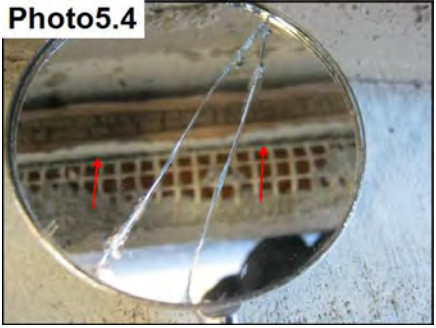
Photo5.4

White house wrap visible.

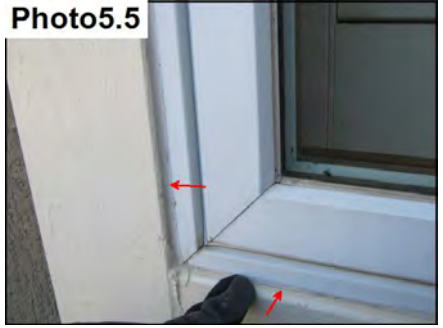
Photo5.5

Thin sealant visible.

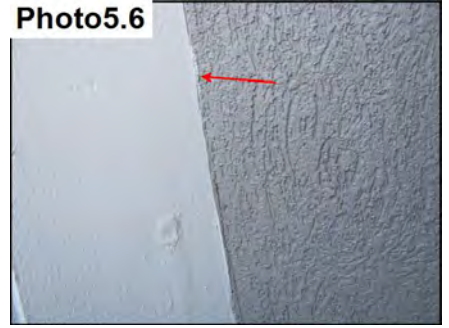
Photo5.6

Missing sealant trim abutments.

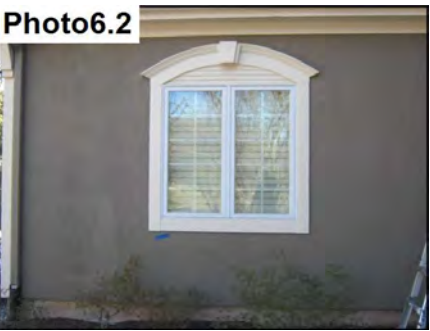
Probe area 3

| Grid Location | Item Description | Moisture Readings | Substrate Condition | Observations | Chapter Reference |
|---|---|---|---|---|---|
| A7 | Probe 3 | 11.0 | Firm | Inadequate sealants | |

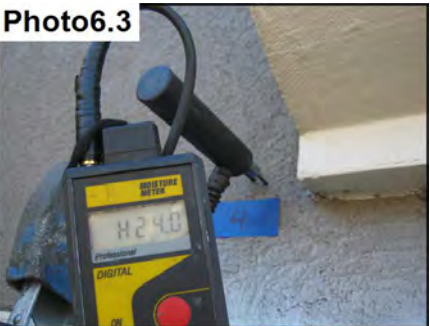
Probe 4 elevated moisture

| Grid Location | Item Description | Moisture Readings | Substrate Condition | Observations | Chapter Reference |
|---|---|---|---|---|---|
| A4 | Probe 4 | 24 | Firm | Elevated Moisture | |

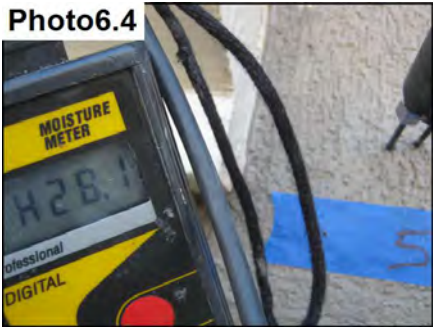
Probe 5 elevated moisture

| Grid Location | Item Description | Moisture Readings | Substrate Condition | Observations | Chapter Reference |
|---|---|---|---|---|---|
| C4 | Probe 5 | 28.1 | Firm | Elevated Moisture | |

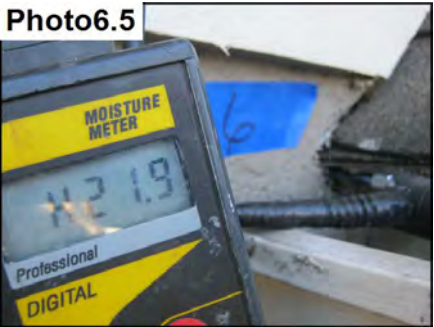
Probe 6 elevated moisture

| Grid Location | Item Description | Moisture Readings | Substrate Condition | Observations | Chapter Reference |
|---|---|---|---|---|---|
| G4 | Probe 6 | 21.9 | Firm | Elevated moisture/missing kickout. | |

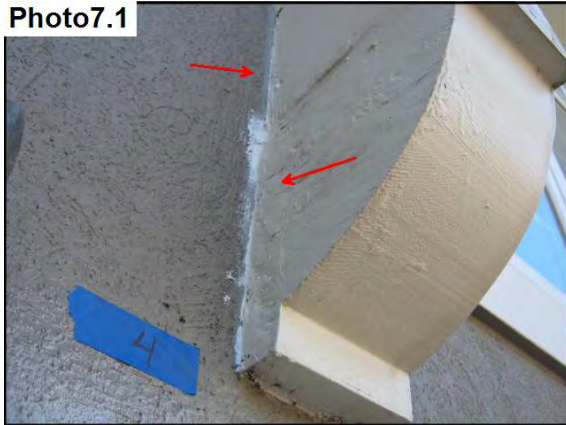
Photo7.1

Wood rot repair, inadequate sealant.

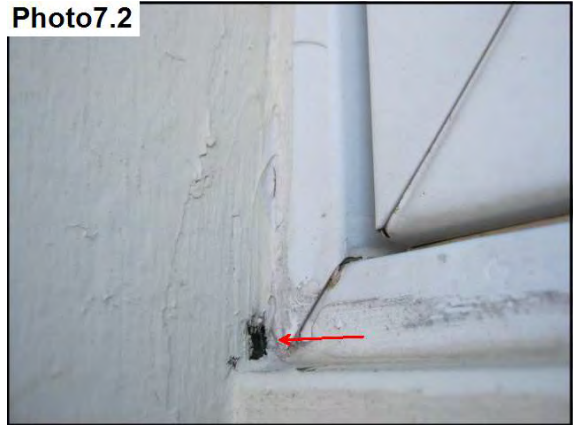
Photo7.2

Hole in trim

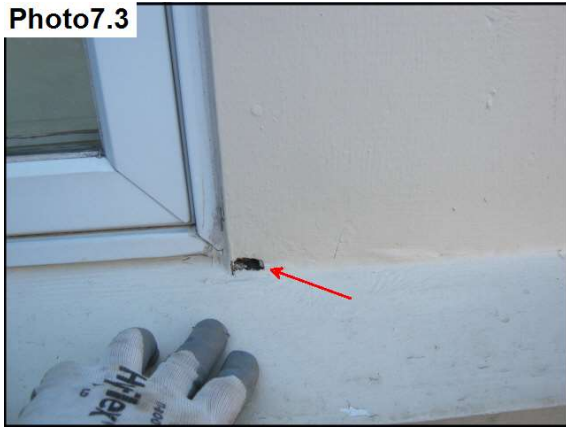
Photo7.3

Hole in trim

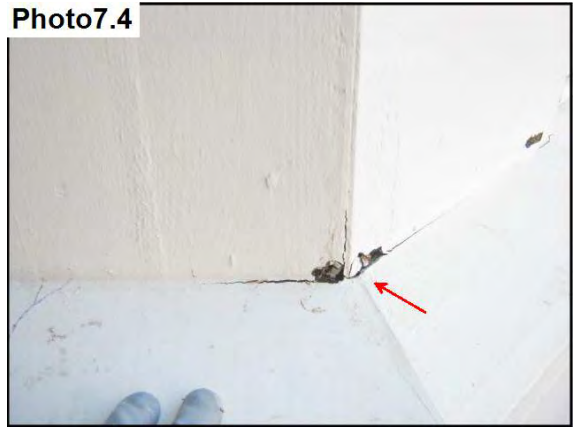
Photo7.4

Wood rot at column

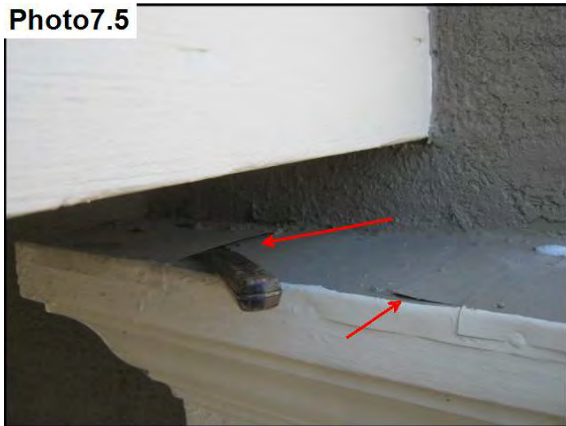
Photo7.5

Top column flashing not sealed.

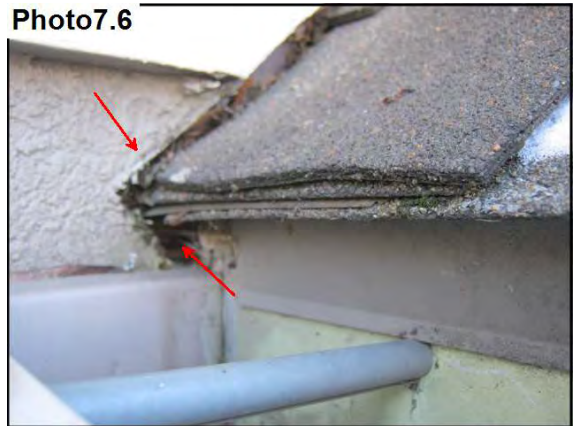
Photo7.6

Wood sheathing visible, missing kickout.

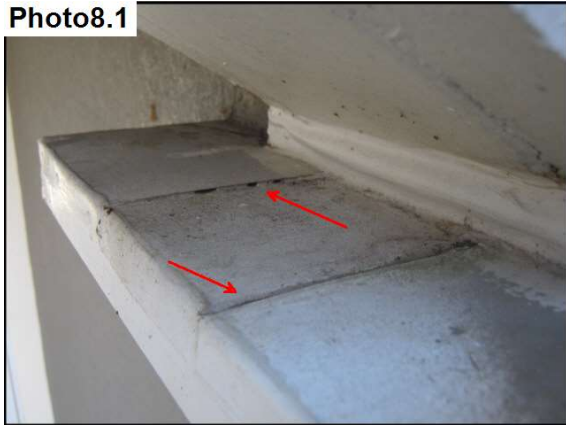
Photo8.1

Column flashing not sealed

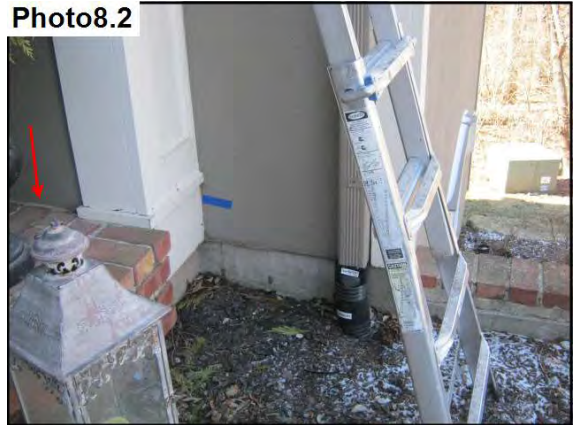
Photo8.2

EIFS in contact with brick

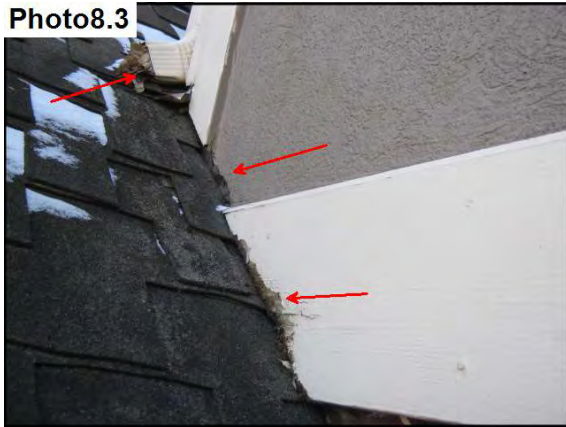
Photo8.3

Trim/EIFS in contact with roof shingles.

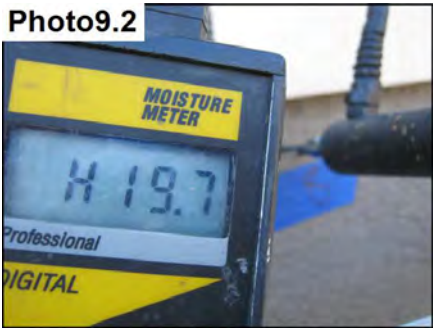
Probe 8 elevated moisture

| Grid Location | Item Description | Moisture Readings | Substrate Condition | Observations | Chapter Reference |
|---|---|---|---|---|---|
| D3 | Probe 8 | 19.7 | Firm | Elevated moisture | |

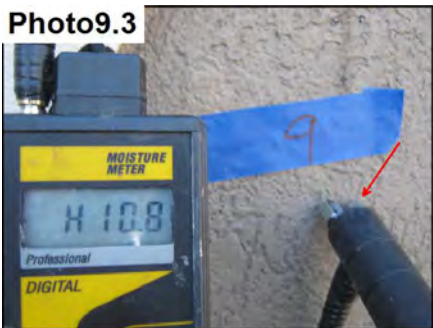
Probe 9 probes go all the way in.

| Grid Location | Item Description | Moisture Readings | Substrate Condition | Observations | Chapter Reference |
|---|---|---|---|---|---|
| G7 | Probe 9 | 10.8 | Soft | Possible dry rot | |

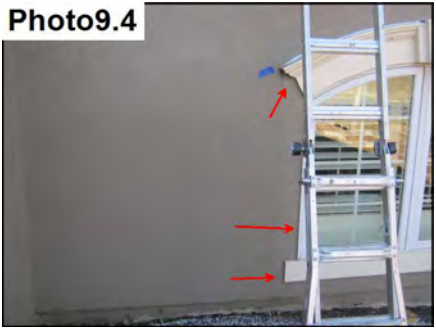
Inadequate sealants

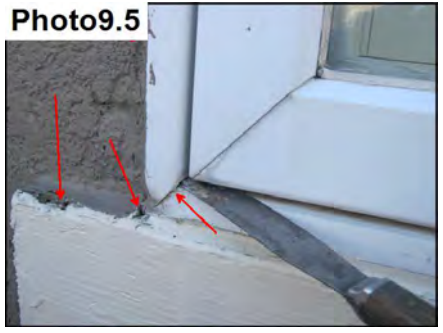
Probe area 8 wood rot and open miter joints. Missing sealant.

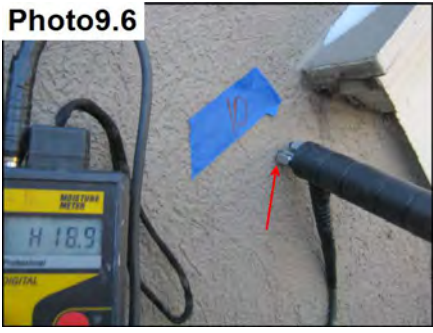
Probe 10 rprobe goes all the way in.

| Grid Location | Item Description | Moisture Readings | Substrate Condition | Observations | Chapter Reference |
|---|---|---|---|---|---|
| G7 | Probe 10 | 18.9 | Soft | Possible dry rot | |

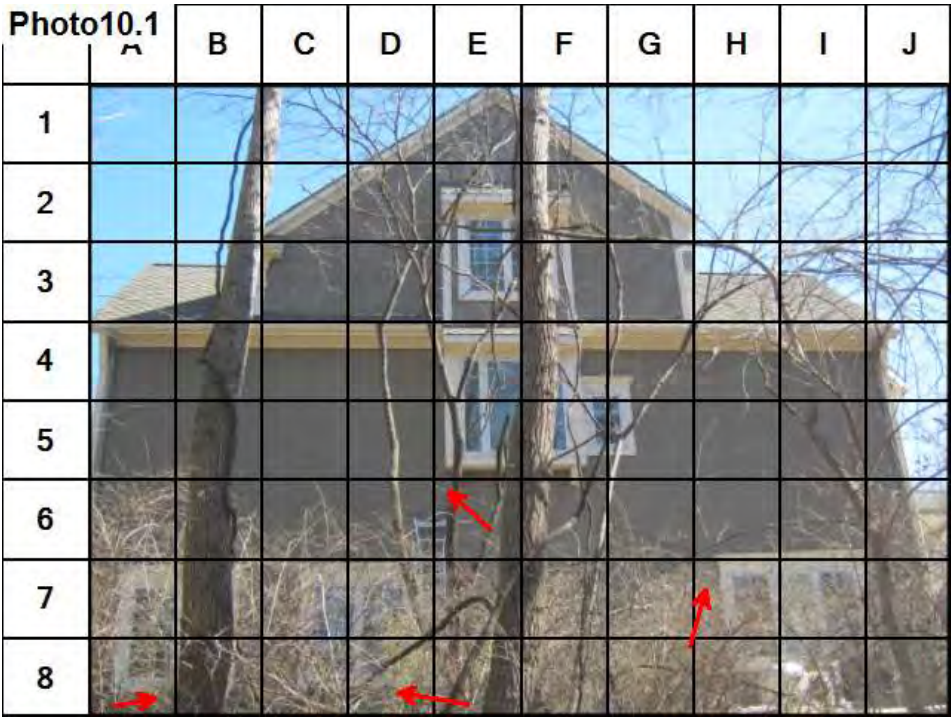
Cracked window bent metal cladding lower window

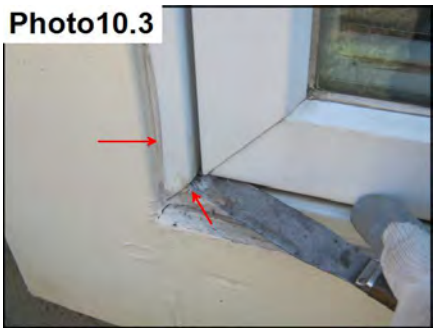
Open miter joints, thin sealant.

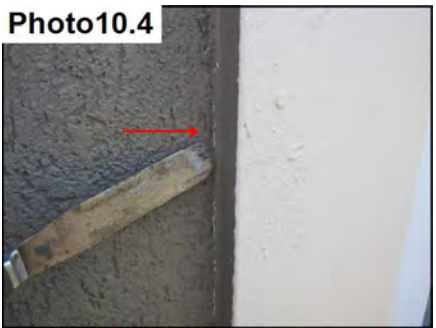
Missing sealant.

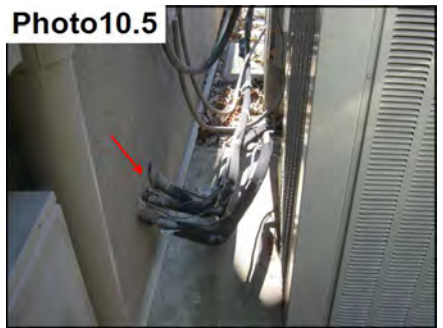
Penetrations not sealed

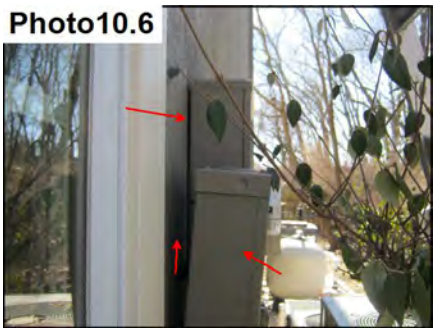
Loose electric. All utilitie boxes not sealed.

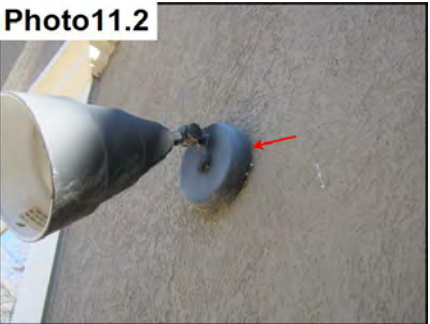
All fixtures not sealed

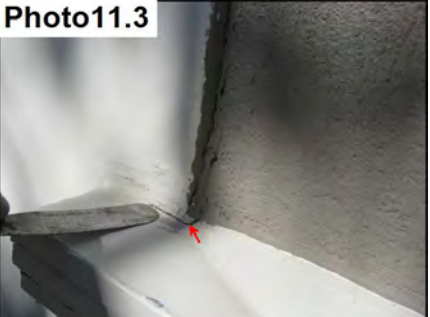
Gaps at head flashing

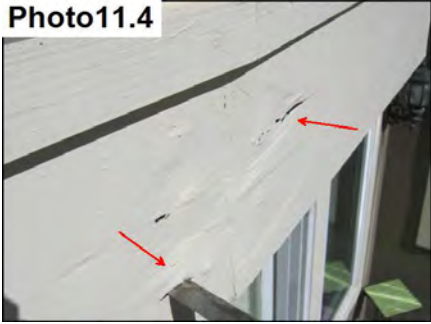
Wood rot

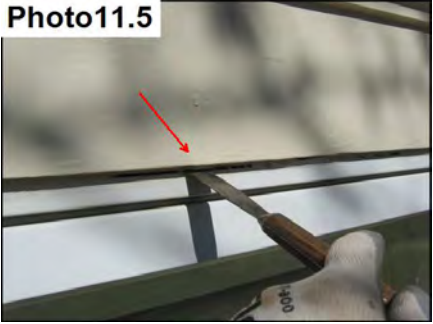
Gaps at wood trim

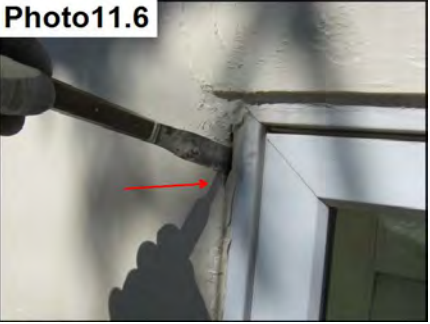
Gaps at joints

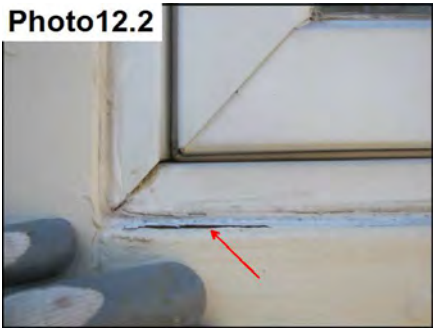
Photo12.2

Inadequate sealant

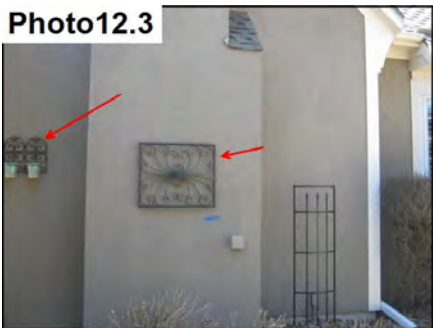
Photo12.3

Improper attachment

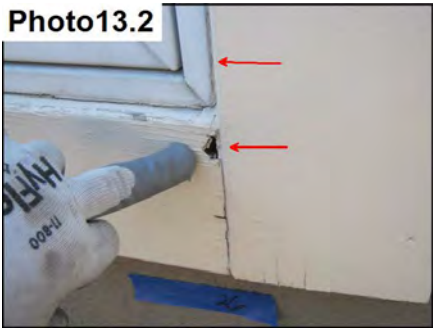
Photo13.2

Wood rot, thin sealant.

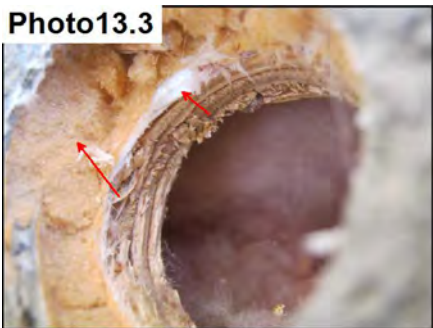
Photo13.3

Hole cut for TV. Yellow foam and white house wrap.

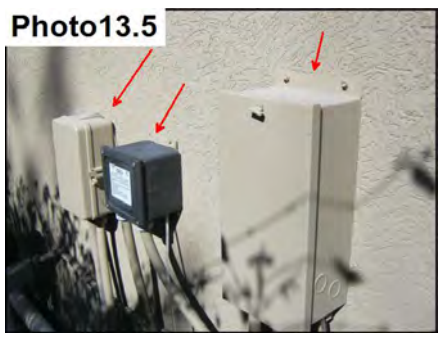
Photo13.5

Utilities on rear garage wall not sealed.

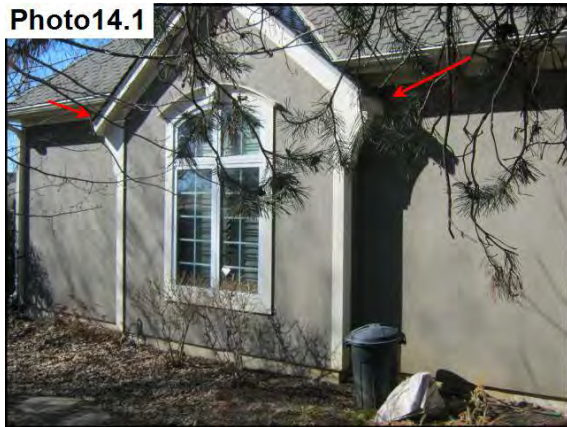
Open gap at roof wall.

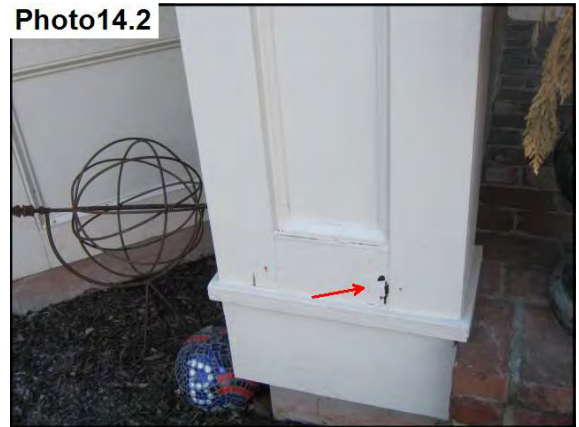
Wood rot at column

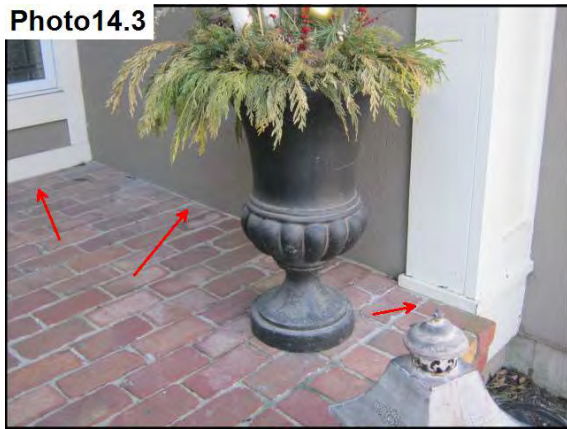
Two inch gap required.

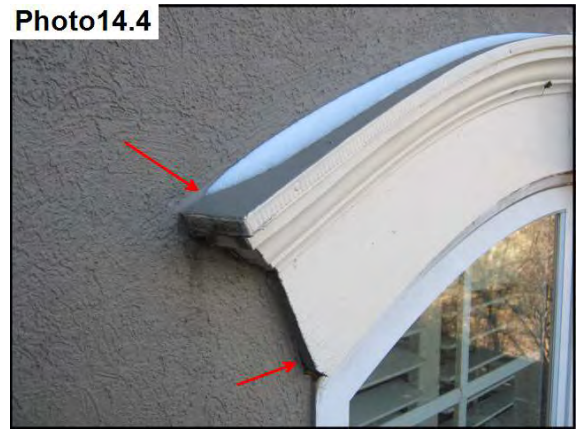
Head flashing installed but gaps at trim.

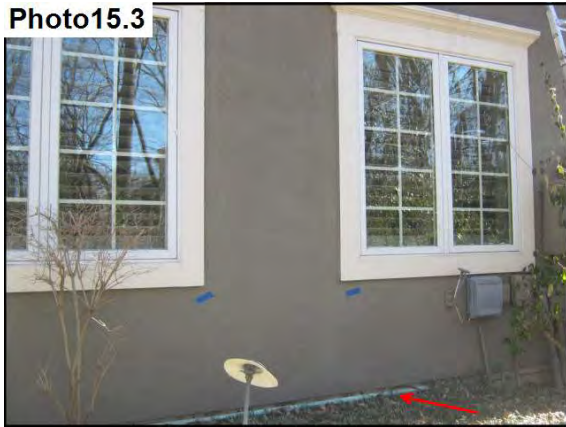
Photo15.3

Good clearance to grade

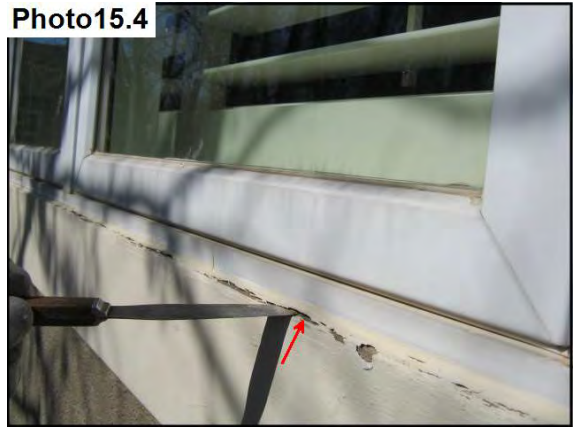
Photo15.4

Sealants too thin to be effective.

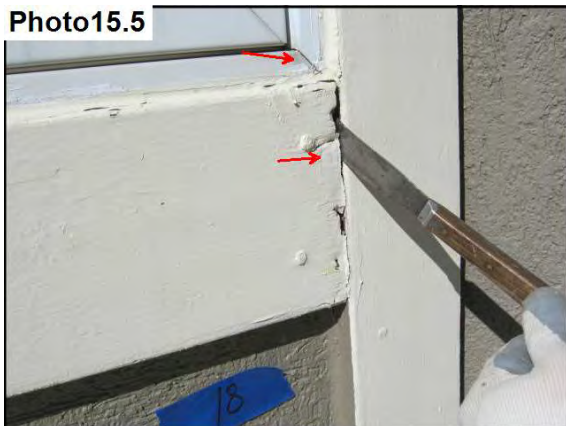
Photo15.5

Wood rot site 18

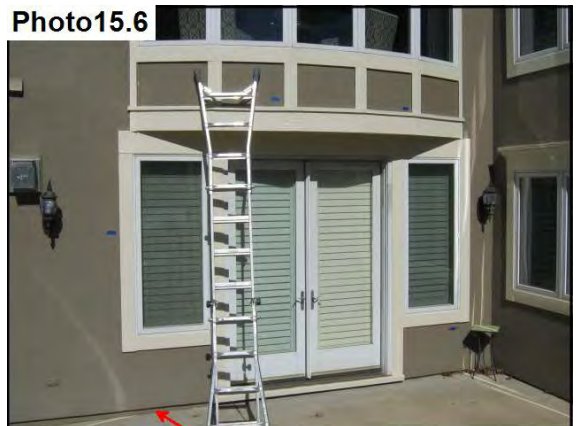
Photo15.6

Good clearance to rear patio
