Fixing a Botched Stucco Job

No matter how good the new finish looks, success depends on what's underneath

by Dave Haines

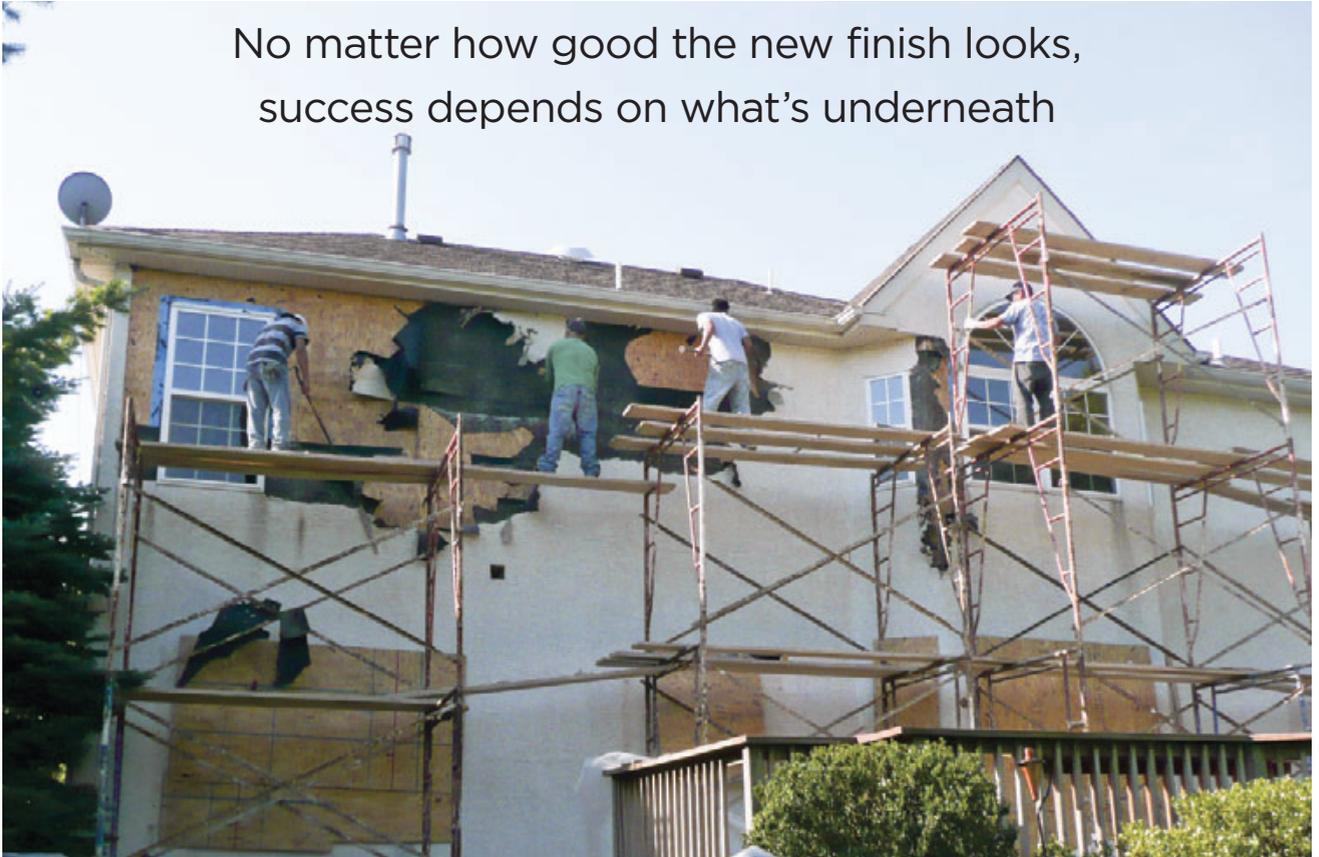
Late last year, a couple called me about some leaking windows on the back of their 5-year-old stucco house (above). My company hadn't built the home; it was part of a tract development in Southeastern Pennsylvania thrown up during the recent housing boom. Other houses in the neighborhood had similar problems, and the owners were frustrated that, despite several attempts, the original builder hadn't been able to stop the leaks. They called me because I had fixed the same problem for neighbors across the street.

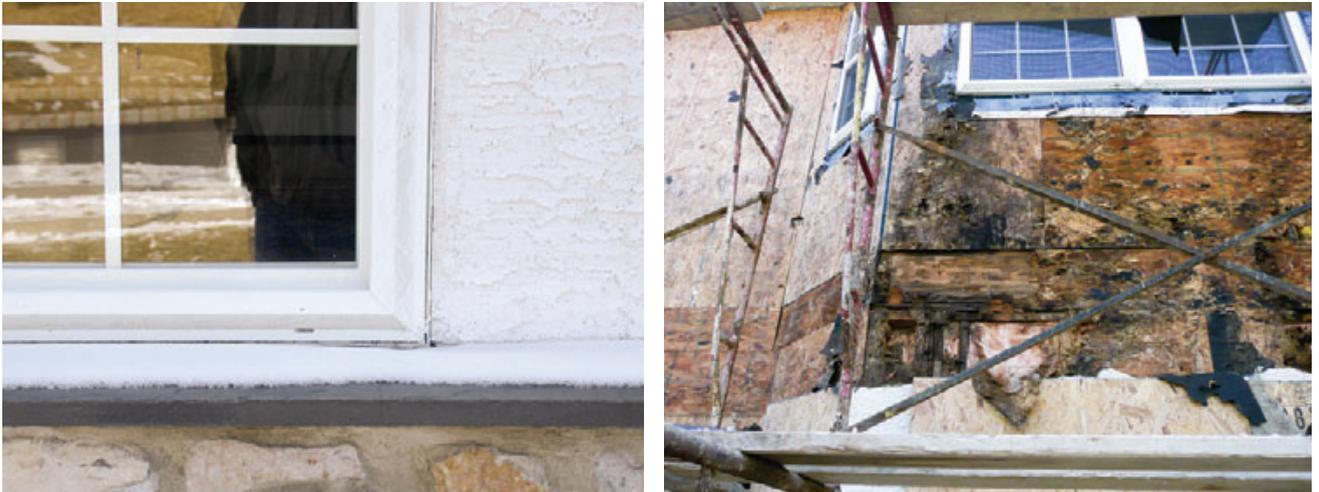
a leaky stucco wall is a poorly detailed drainage plane, and that was certainly the case here. The first thing I noticed was that there was no casing bead around the windows (see Figure 1, next page). Casing bead creates a separation between the stucco and the window or door casings, so that the framing and sheathing can expand and contract without cracking the stucco or the windows. There's a vinyl casing bead called E-Z Bead (amico-lath.com, 800/366-2642) made just for this purpose, but vinyl J-channel and backer rod work just as well.

problematic on a new home, where lumber can shrink a lot as it dries, placing great stress on casings and windows. On this house, movement in the frame had cracked some of the vinyl windows' welded joints, allowing rain to get into the wall and leak into the house around the interior casings. If the windows had been properly installed, this water would have been directed back to the outside, so I suspected improper flashing, but there was no way to be sure without removing the stucco.

Figure 1. When the author investigated this home's leaky windows, he found that the stucco was tight against the window frames — an indication that no casing bead had been installed (left). When the stucco was removed, extensive rot was discovered in both sheathing and framing (right).

After covering the decking and ground-floor windows with plywood to protect against falling debris, the stucco contractor removed the stucco so we could see the extent of the damage. As suspected, the windows had been set in unflashed rough openings with their flanges taped to the sheathing, even across the bottom, so any water that leaked in was trapped. In some places, not only the sheathing but also the framing behind it had rotted. A total of 11 windows and doors needed to

the affected wall, removing and reinstalling the windows and doors with proper flashing, and applying new stucco. Replacing any rotted framing and sheathing we found would cost extra. The wall finish would consist of a layer of Tyvek StuccoWrap, a layer of Grade D felt paper, metal lath, and a three-coat stucco finish.

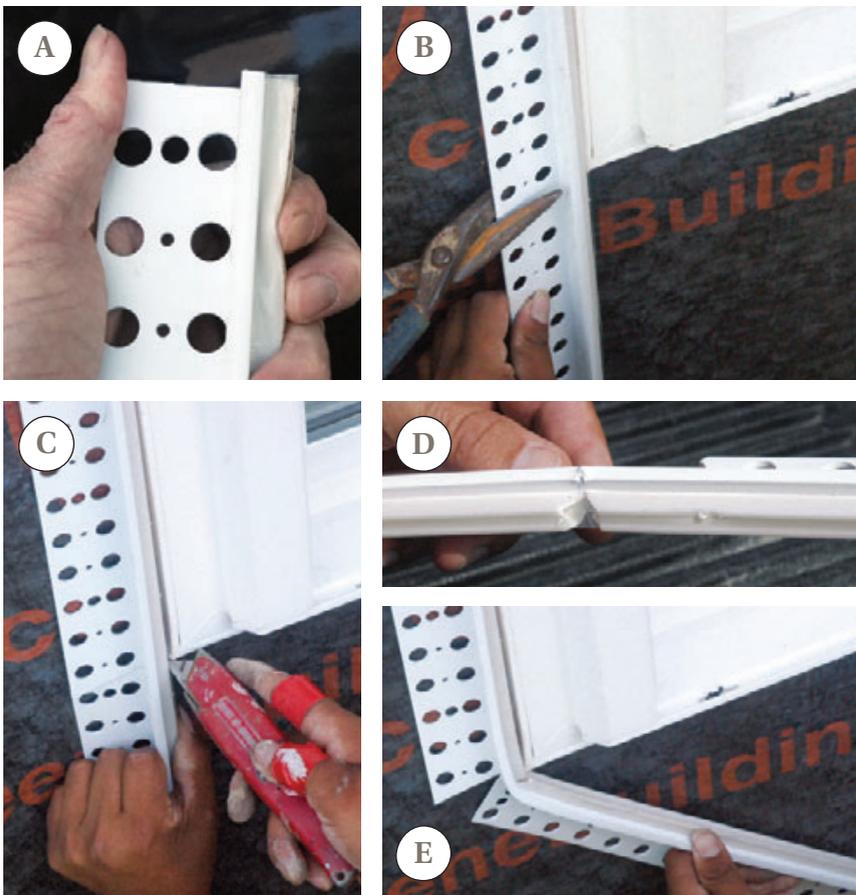
Figure 2. Designed for quick installation, E-Z Bead has an integral foam bond break (A). To install it around the sides and bottom of the window, you snip the vinyl (B), cut a notch out of the foam (C, D), and fold it around the frame (E).

At the suggestion of our stucco contractor, we actually removed the 2x4 rough sills and ran them through a table saw to create a 5-degree bevel. We then reinstalled the sills and windows, following the flashing sequence described in the drawing on the previous page. The entire process took about 30 minutes per opening, including applying the casing bead. As mentioned above, E-Z Bead and vinyl J-channel are equally effective; with either one, the bead is separated from the casing by a flexible sealant joint. E-Z Bead has an integral foam extrusion that serves as the base for the sealant (Figure 2, page 2), while J-channel requires the use of foam backer rod (Figure 3).

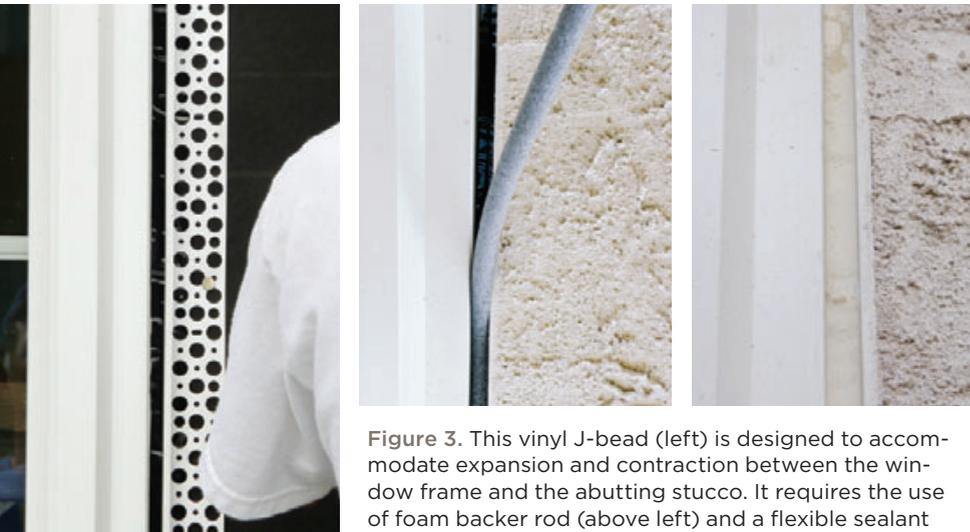
Figure 3. This vinyl J-bead (left) is designed to accommodate expansion and contraction between the window frame and the abutting stucco. It requires the use of foam backer rod (above left) and a flexible sealant (above right).

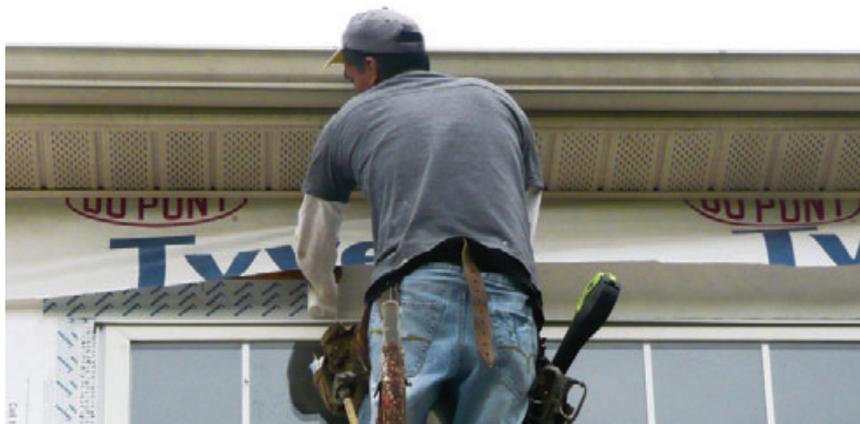
Figure 4. A worker lifts the StuccoWrap along the top of the wall to tape the top fin of the window to the sheathing (above). Metal lath is installed on top of Grade D paper in preparation for stucco (left).

Soffit protection. Because our stucco contractor had seen cases where wind-driven rain had entered soffits and soaked the sheathing, he also recommended that we remove the soffits and install strips of StuccoWrap along the top of the wall (Figure 4). We cut the strips wide enough so that the paper would run several inches past the bottom of the reinstalled soffits, bringing any water that blew up into the eaves back onto the drainage plane.
