LESTER
INSPECTION SERVICES
• InterNACHI-Certified •

Home Inspection Report

12101 e 57th st, Kansas City , MO 64133

Thursday June 25, 2020

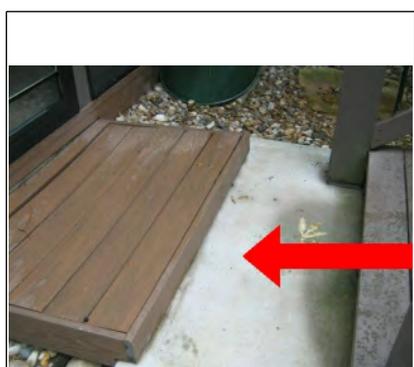
Comments Step are uneven at rear landing, may present a trip hazard. Recommend repair and/or replacement

Trip hazard rear deck

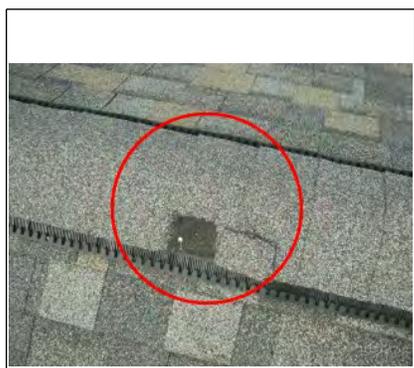
Ridge vents installed, damaged shingle above garage

Comments Two broken shingles at garage ridge vent.

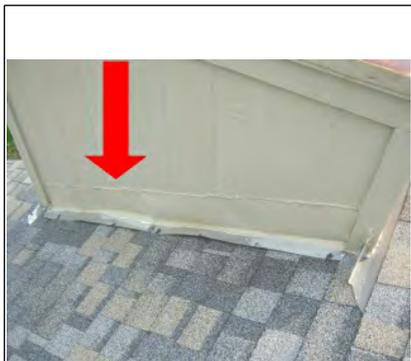
Poor flashing detail at chimney chase, open gaps at top.

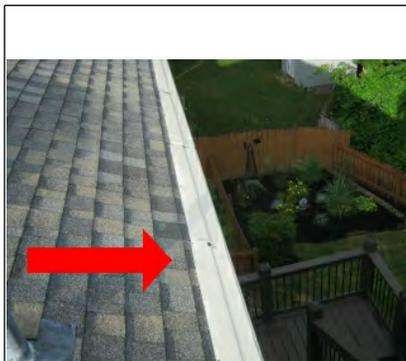
Rear leaf guard should be installed under shingles , nail heads will cause leaks.

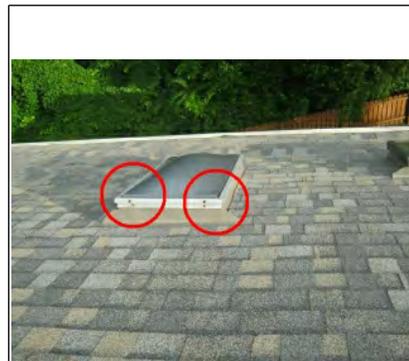
Rusted fasteners on skylights, galvanized or stainless required

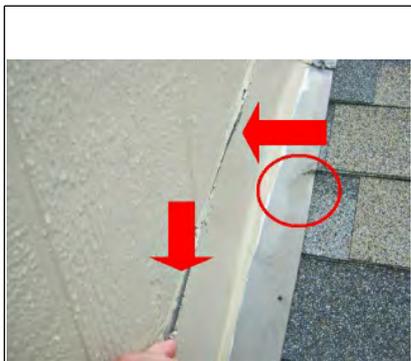
Gaps at chimney flashing , nail heads not sealed.

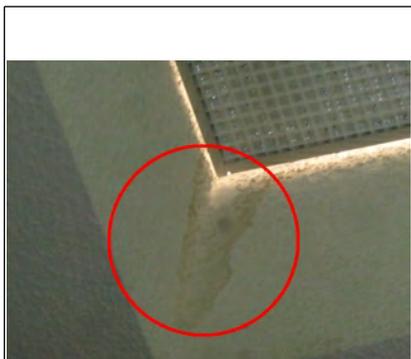
Comments Water stains on interior observed, contractor to seal skylights.
 Most skylight stains are from condensate, paint stain at skylight and monitor.

Water stains

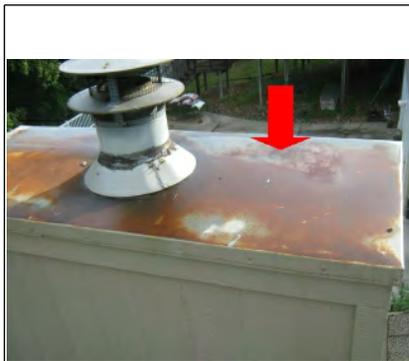
Comments Rusted metal chimney crown, recommend sealing and sloping so it does not hold water.

Rust and ponding.

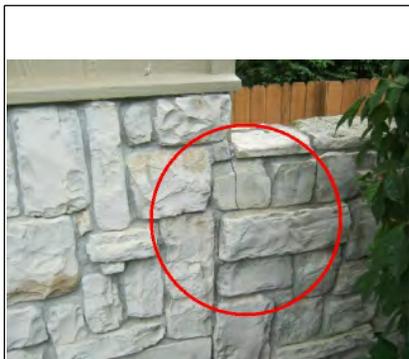
Crack at right side

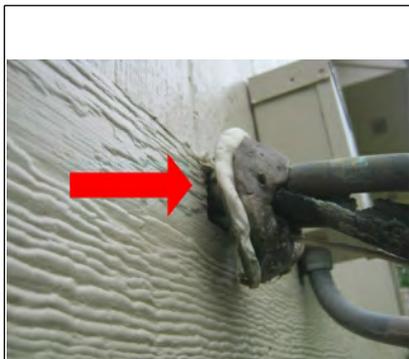
Seal all penetrations

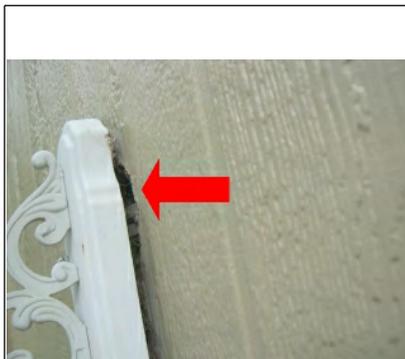
Seal all light fixtures

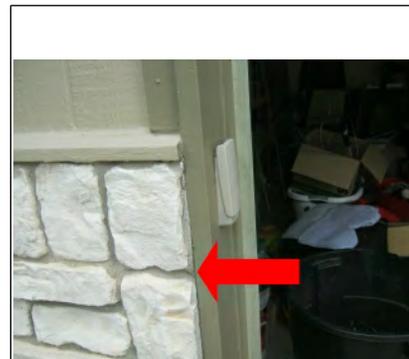
Seal all dissimilar materials

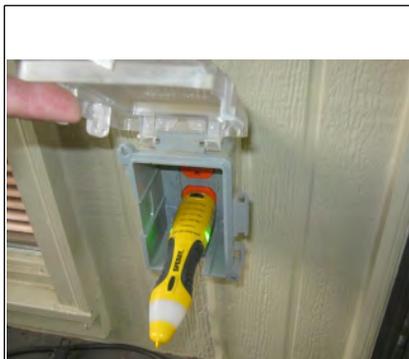
Upper rear outlet not GFCI

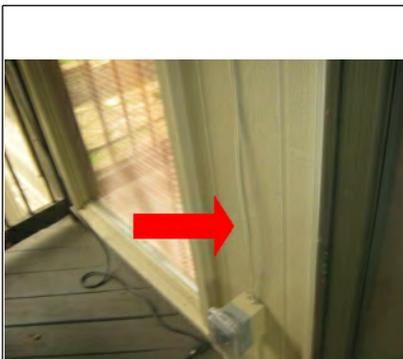
Cable for upper rear outlet must be in a conduit

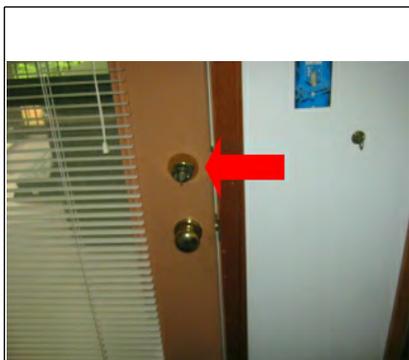
Comments Both upper and lower rear doors are keyed to the interior, fire safety hazard.

Keyed to interior, safety hazard.

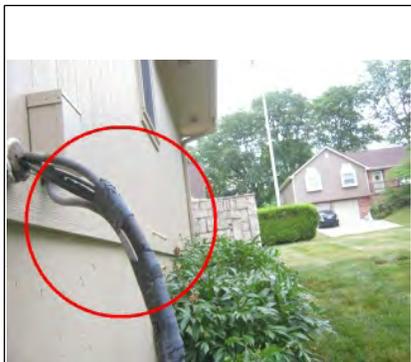
Replace insulation

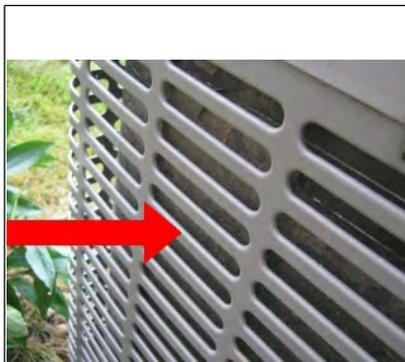
Clean fins

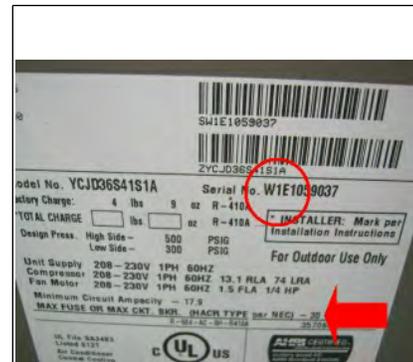
Comments Outside condenser unit coils dirty recommend cleaning
 Heat pump/AC was in normal working order.
Breaker at main panel is 40 amp, recommend 30 amp breaker as listed on AC condenser label

Manufactured in 2011, 30 amp breaker is max.

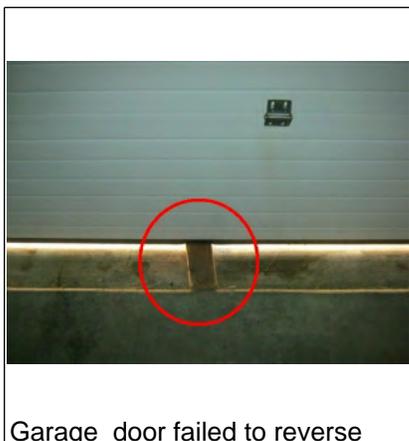
Comments Garage door failed to reverse when contacting a 2x4 laid flat.

Garage door failed to reverse

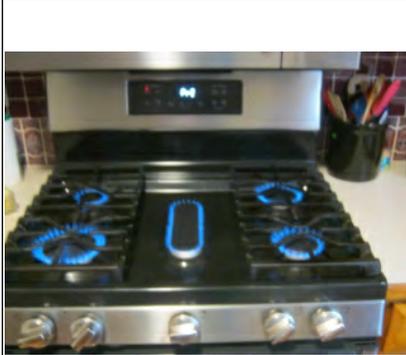
Comments cont. inspection
Oven/range missing anti-tip device missing, child safety hazard.

Missing anti-tip device, but hits microwave.

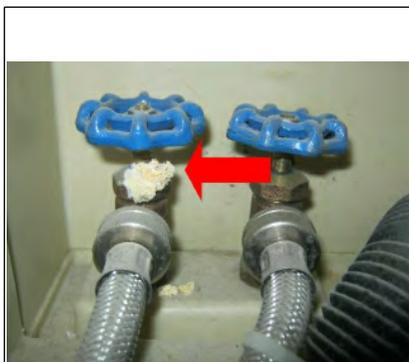
Comments Clean and monitor corroded fittings.

Clean and monitor washer corroded connections.

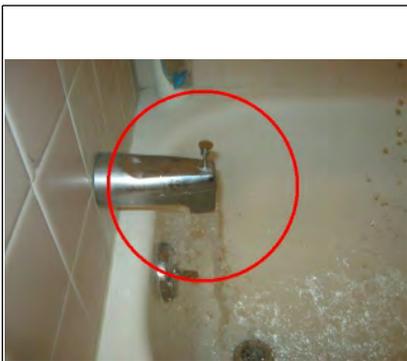
Comments Recommend venting exhaust fan to exterior
No active supply piping leaks at the time of this inspection.
Tub spout shower divert not working reccomend repair.

Replace tub spout divert

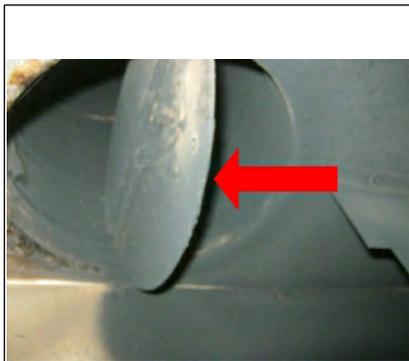
Comments Wood burner fireplace with gas log set, reccomend damper lock, safety hazard.

No damper lock

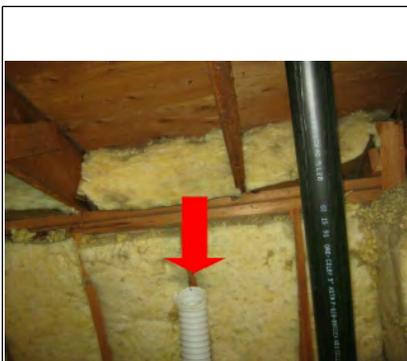
Reccomend extending bath vents to the exterior

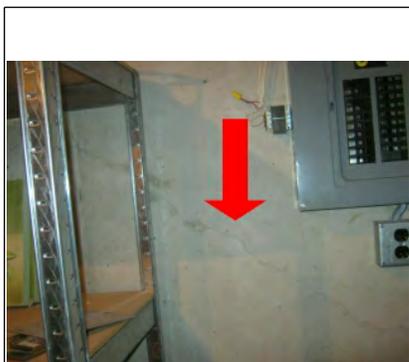
Comments Limited view of basement wall, one step crack observed at electrical panel.
 Foundation showed only typical minor shrinkage cracks.
 Foundation appeared to be in overall satisfactory condition.

Step crack

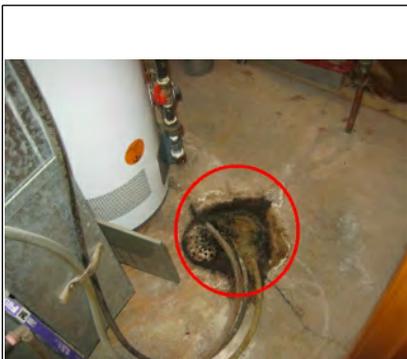
Clean floor drain

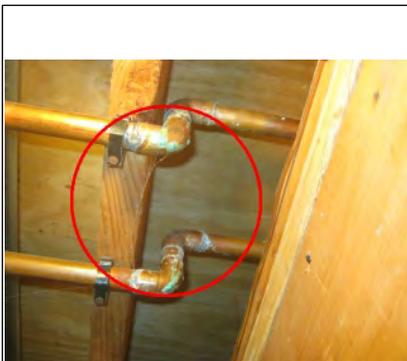
Clean and monitor corroded water line in furnace room.

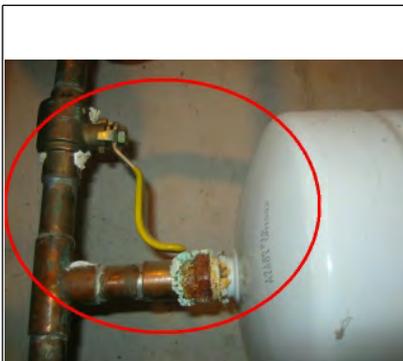
Comments Water heater expansion tank fitting have excessive corrosion and slight corrosion at shut off valve, recommend repair.

Replace corroded fittings

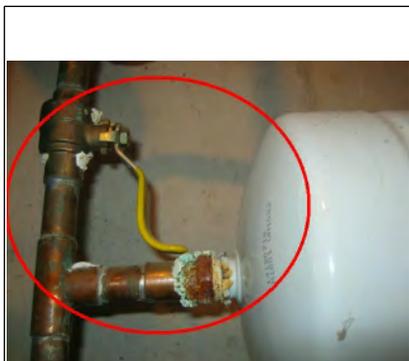
Water heater past or nearing life expectancy, budget for replacement.
Corroded expansion tank fitting.

Corroded fittings

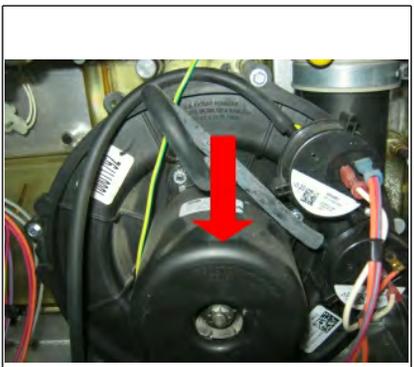
Comments Inducer fan bearings on furnace sounded defective and may need repair.

Loud noise from inducer fan

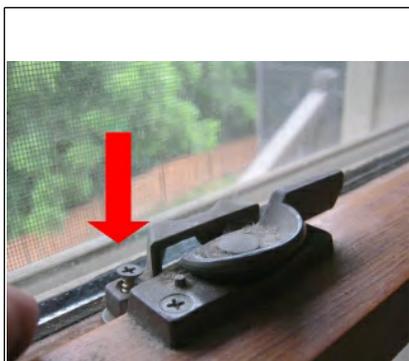
Comments Minor window latch repair needed on wood windows.

Stripped screw master bedroom
