Fixing a Botched Stucco Job

No matter how good the new finish looks, success depends on what's underneath

by Dave Haines

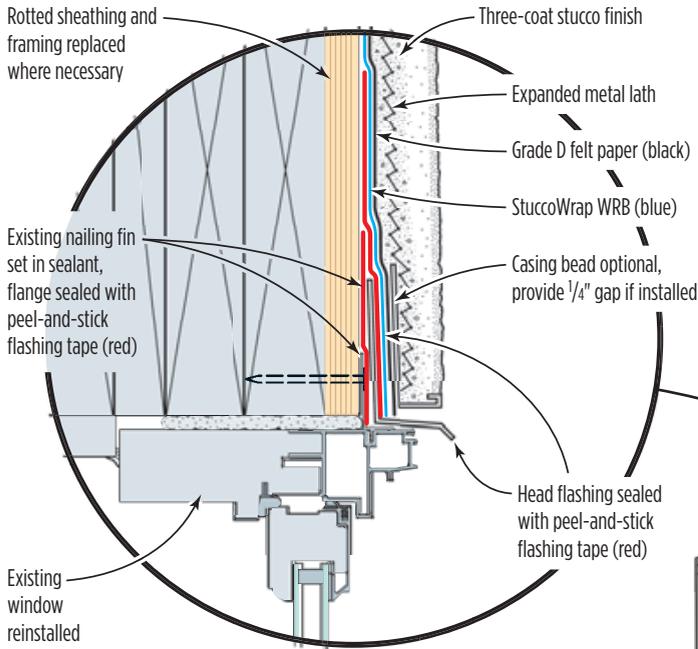
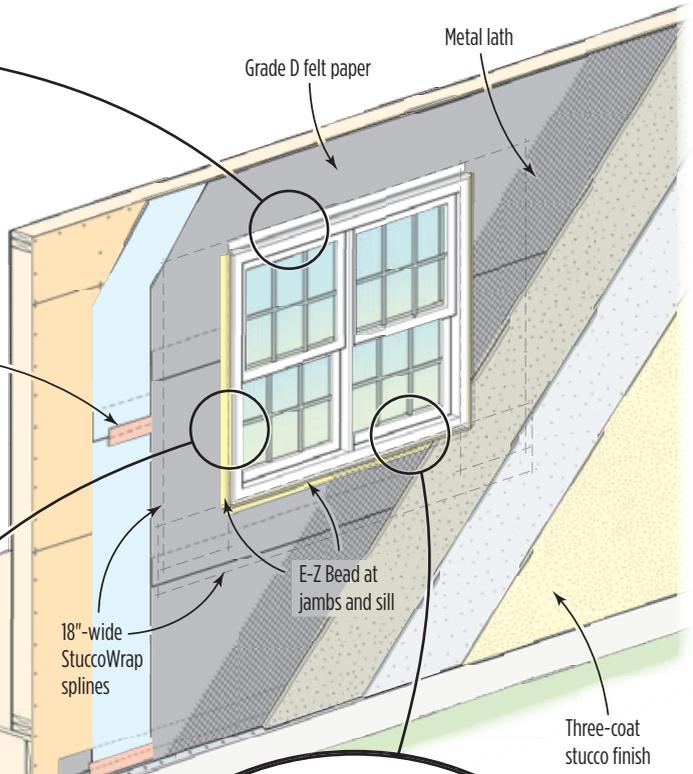
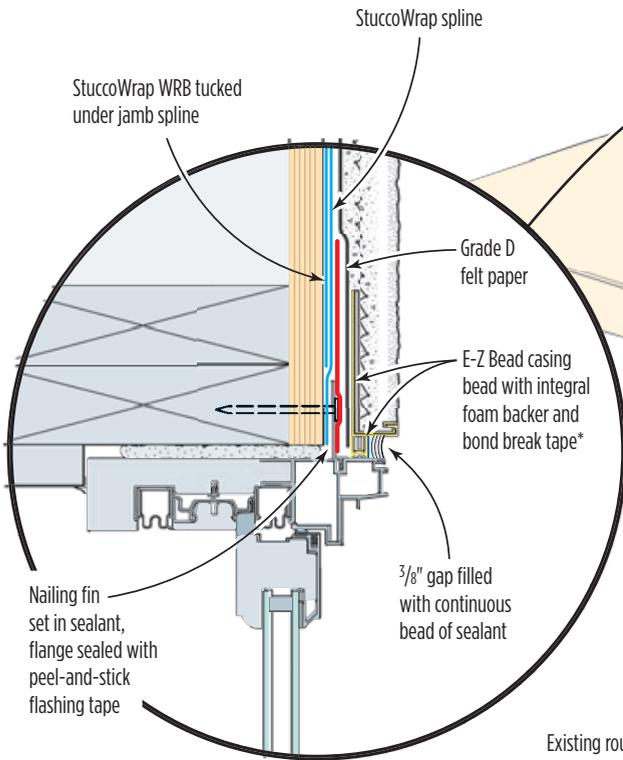
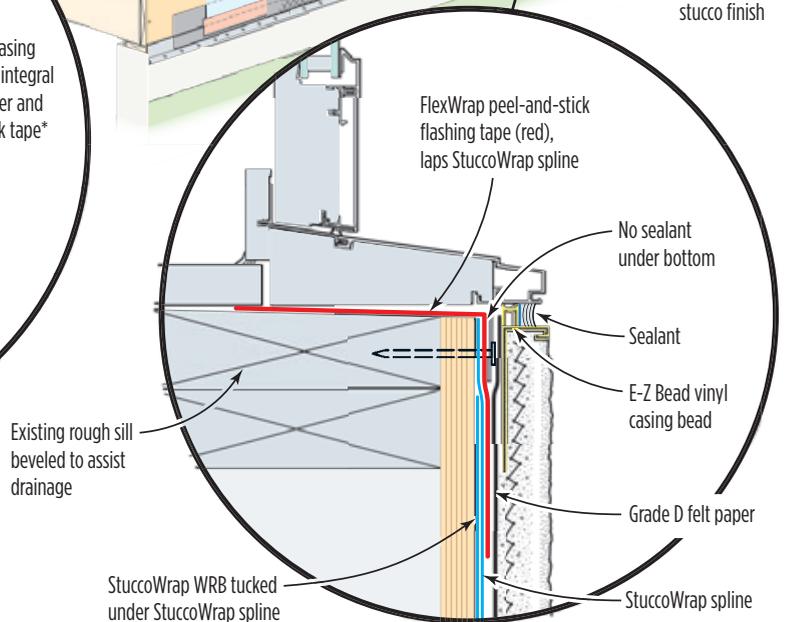
Installing Windows in Stucco

For leakproof stucco, the window installation crew has to use appropriate details. On the repair job described in this article, the GC's crew properly flashed the windows, leaving wide StuccoWrap splines on the sides and bottoms for the stucco crew to tuck the water-resistant barrier (WRB) behind. The window crew also installed vinyl expansion bead around the window frame — an important detail too often omitted.

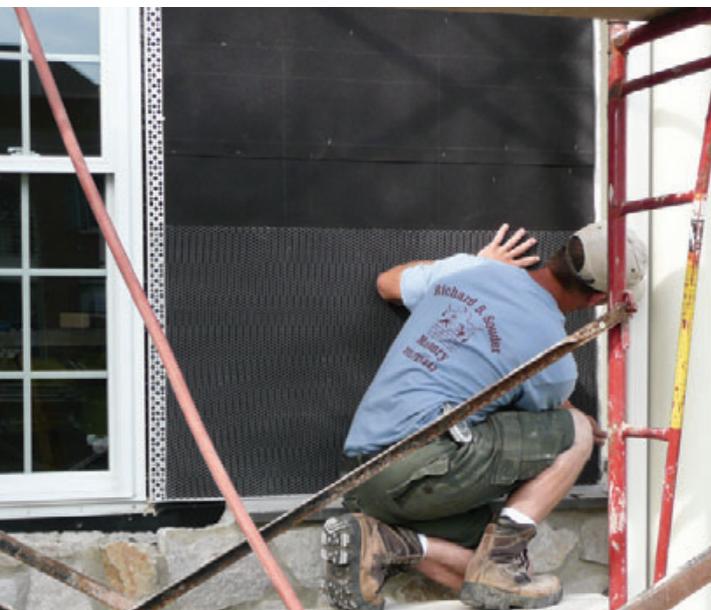
Figure 4. A worker lifts the StuccoWrap along the top of the wall to tape the top fin of the window to the sheathing (above). Metal lath is installed on top of Grade D paper in preparation for stucco (left).

Soffit protection. Because our stucco contractor had seen cases where wind-driven rain had entered soffits and soaked the sheathing, he also recommended that we remove the soffits and install strips of StuccoWrap along the top of the wall (Figure 4). We cut the strips wide enough so that the paper would run several inches past the bottom of the reinstalled soffits, bringing any water that blew up into the eaves back onto the drainage plane.
